Hazardous Materials Accident Report

Hazardous Materials Release From Railroad Tank Car With Subsequent Fire at Riverview, Michigan July 14, 2001

**National
Transportation
Safety Board**
Washington, D.C.

**NTSB/HZM-02/01
PB2002-917002
Notation 7400A
Adopted June 26, 2002**

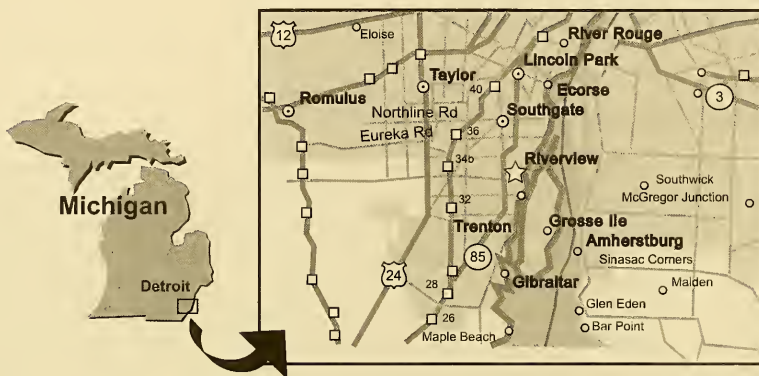
Figure 1. Accident site.

From 2:00 until 3:00 a.m. on July 14, 2001, employees at the ATOFINA plant in Riverview, Michigan, (see figure 1) removed three empty¹ tank cars from the Process 46² loading area and replaced them with three full tank cars. Two of the loaded tank cars were filled with chlorine, a poisonous gas, and one was filled with methyl mercaptan, a poisonous and flammable gas. In the Process 46 area, the tank cars were to be used to feed the chlorine and methyl mercaptan into the production process for the production of several other materials. (See figure 2.)

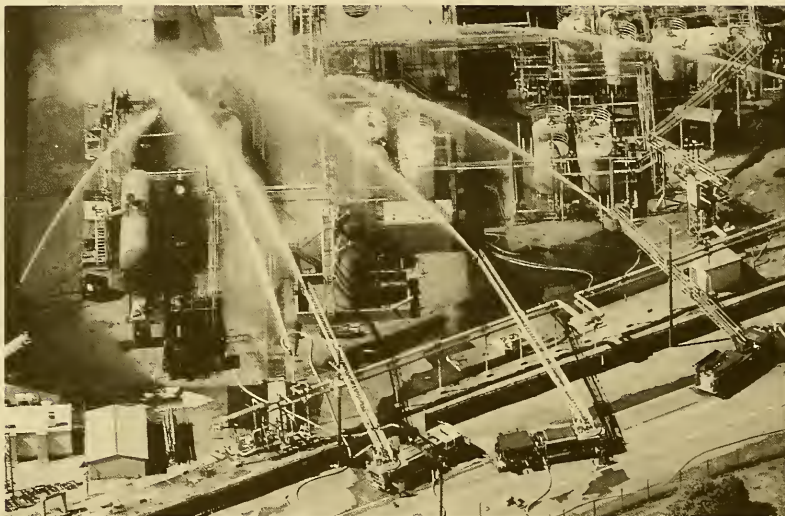
Figure 3. Overview of accident site and emergency response.

resulted in a fireball that extended an estimated 200 feet into the air. When the fireball occurred, the Riverview fire chief requested mutual aid from the surrounding communities. Riverview Fire Department responders began applying water to the tank cars involved in the fire and to the adjacent tank cars to keep them cool. (See figure 3.) Units from the Wyandotte, Trenton, and Brownstown Fire Departments, and the Downriver Mutual Aid HAZMAT Team⁶ responded.
